**Company Name:** Bath Road (Swindon) Management Limited

**Inspector Name:** Thomas Dellow AIRPM

**Inspection Date:** 07 February 2023

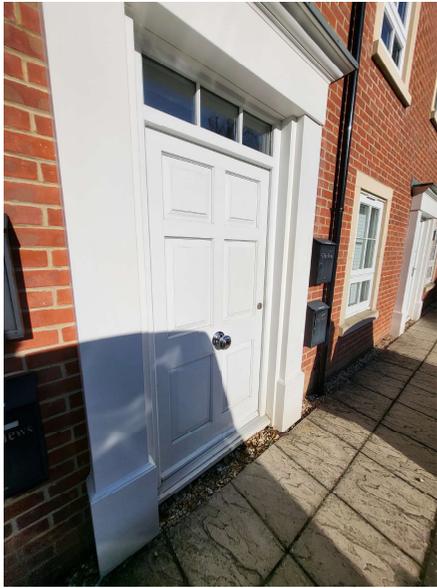
**Entrances (Main Doors)**

Internal Inspection	Acceptable	Not Acceptable	N/A	Comments	Action
<b>Entrances</b> (Main doors)	✓			The main entrance is secured via key which was secure and operational at time of inspection.	None
<b>Hallway</b> (Communal Lobbies and Stairs)	✓			The communal hallways were tidy, cleaning is undertaken by residents.	None
<b>Lighting</b> (Standard and Emergency Lighting)	✓			The lighting appeared in good visual condition, emergency lighting is inspected by residents.	None
<b>Internal Doors</b> (Compartment Doors)			✓	There are no internal compartmenting doors.	None
<b>Cupboard Doors</b> (Electrical Cupboard Doors)	✓			The electrical cupboards were functional and secure.	None
<b>Windows</b> (Communal Windows)	✓			The communal windows appeared in good visual condition.	None
<b>Signage</b> (Communal Notices)	✓			The communal notice board was updated and accessible.	None
<b>Additional Comments</b>					None

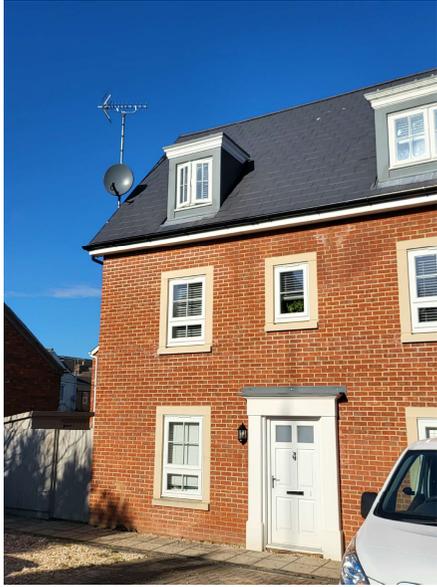
**Exterior Structure (The Building)**

External Inspection	Acceptable	Not Acceptable	N/A	Comments	Photos
<b>Exterior Structure</b> (The Building)	✓			The exterior appeared in good visual condition.	None
<b>Guttering</b> (Gutters and Fascia)	✓			The guttering and fascia appeared in good visual condition.	None
<b>Roofing</b> (Tiles and Cladding)	✓			The roof appeared in good visual condition.	None
<b>Communal Grounds</b> (Gardens and Common Areas)	✓			The communal grounds were tidy.	None
<b>Bin Store</b> (Waste Disposal Areas)			✓	There is no communal bin store.	None
<b>Car Park</b> (Vehicle Parking)	✓			The car park was accessible.	None
<b>Bike Store</b> (Bicycle Areas)			✓	There is no communal bike store.	None
<b>Additional Comments</b>					None
