Company Name: Bath Road (Swindon) Management Limited

Inspection Date: 17 April 2025

Purpose

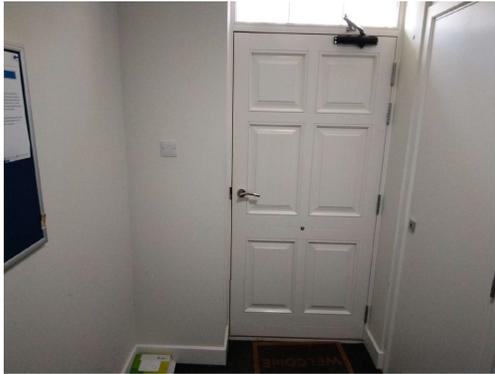
Entrances (Main Doors)

| Internal Inspection | Acceptable | Not Acceptable | N/A | Comments | Action |
|--|---|---|---|--|---|
| Entrances (Main doors) | ✓ | | | Main entrance doors were secure and operated without issue. | None |

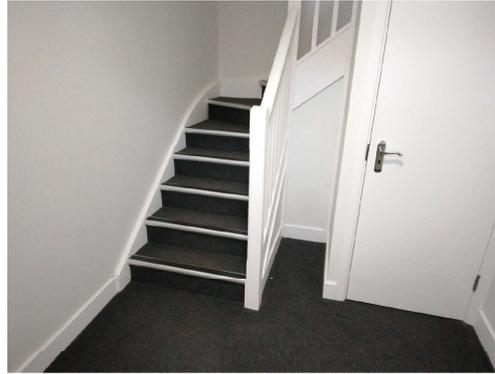
| Internal Inspection | Acceptable | Not Acceptable | N/A | Comments | Action |
|--|---|---|---|--|---|
| Hallway (Communal Lobbies and Stairs) | ✓ | | | Hallways and stairs were clean, clear and free from obstructions. | None |

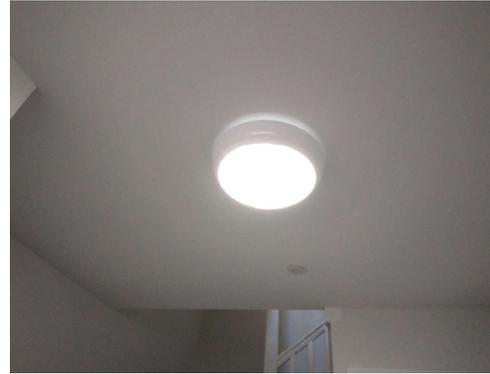
Lighting (Standard and Emergency Lights)

| Internal Inspection | Acceptable | Not Acceptable | N/A | Comments | Action |
|--|---|---|---|--|---|
| Lighting (Standard and Emergency Lighting) | ✓ | | | Emergency lights were tested and passed functionality check. | None |

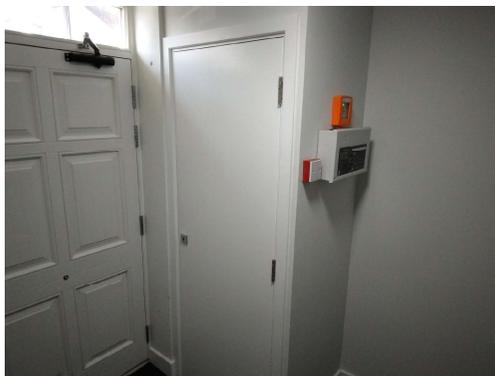
| Internal Inspection | Acceptable | Not Acceptable | N/A | Comments | Action |
|--|---|---|---|--|---|
| Cupboard Doors (Electrical Cupboard Doors) | ✓ | | | No issues noted with access or condition of service cupboard doors. | None |

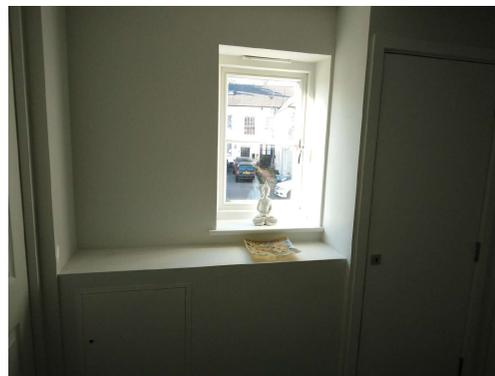
| Internal Inspection | Acceptable | Not Acceptable | N/A | Comments | Action |
|--|---|---|---|--|---|
| Windows (Communal Windows) | ✓ | | | No cracks or defects observed in glass or frames. | None |

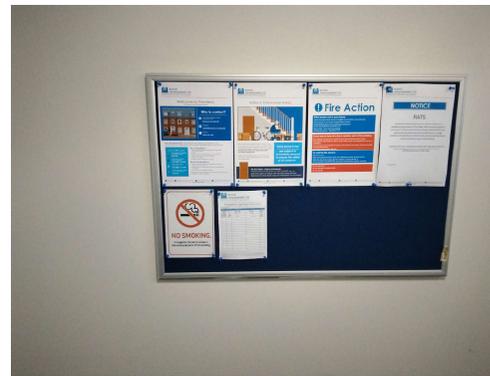
| Internal Inspection | Acceptable | Not Acceptable | N/A | Comments | Action |
|--|---|---|---|--|---|
| Signage (Communal Notices) | ✓ | | | Building noticeboard was clearly displayed and information was up to date. | None |

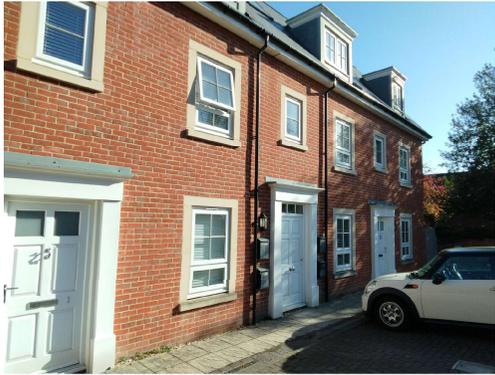
| External Inspection | Acceptable | Not Acceptable | N/A | Comments | Action |
|---|---|---|---|--|---|
| Exterior Structure (The Building) | ✓ | | | No signs of damage or wear were visible on the building's exterior. | None |

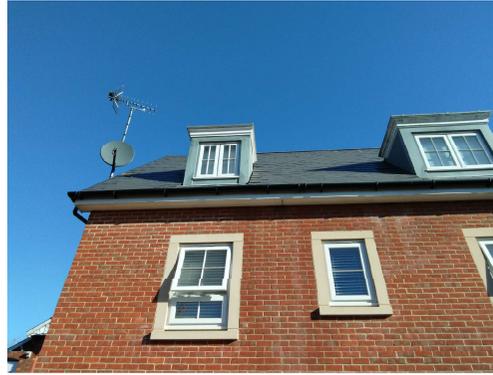
| External Inspection | Acceptable | Not Acceptable | N/A | Comments | Action |
|---|---|---|---|--|---|
| Guttering (Gutters and Fascia) | ✓ | | | No signs of leaks or water overflow; fascia boards also in good condition. | None |

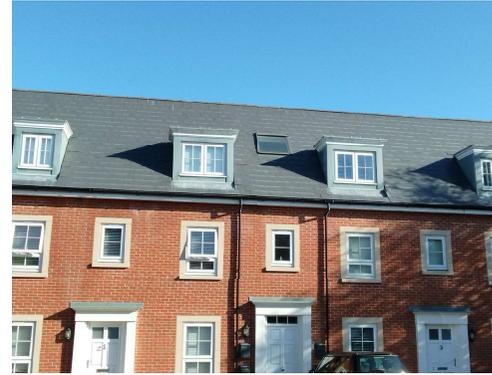
| External Inspection | Acceptable | Not Acceptable | N/A | Comments | Action |
|---|---|---|---|--|---|
| Roofing (Tiles and Cladding) | ✓ | | | Roofing inspected from ground level – no signs of damage noted. | None |

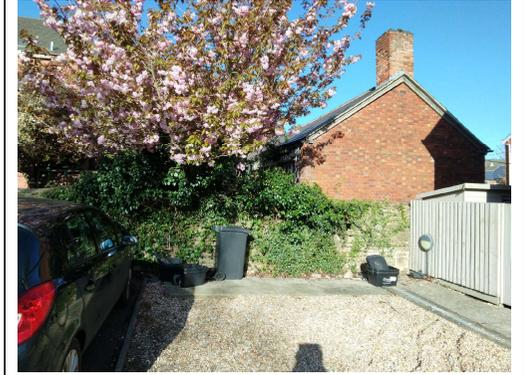
| External Inspection | Acceptable | Not Acceptable | N/A | Comments | Action |
|---|---|---|---|--|---|
| Communal Grounds (Gardens and Common Areas) | ✓ | | | Outdoor spaces were accessible and presented in good condition. | None |

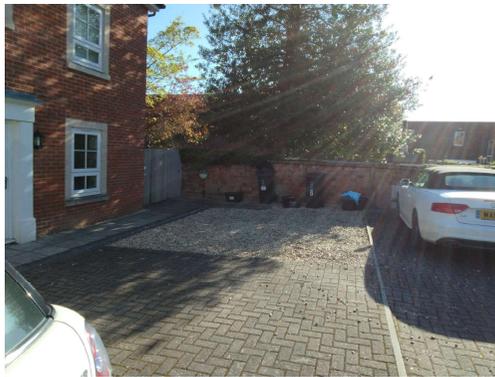
Bin Store (Waste Disposal Area)

| External Inspection | Acceptable | Not Acceptable | N/A | Comments | Action |
|---|---|---|---|--|---|
| Bin Store (Waste Disposal Areas) | ✓ | | | No overflowing waste or unpleasant odours were noted. | None |

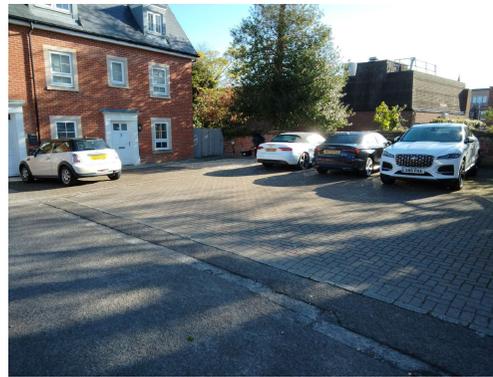
| External Inspection | Acceptable | Not Acceptable | N/A | Comments | Action |
|---|---|---|---|--|---|
| Car Park (Vehicle Parking) | ✓ | | | Parking area is in good visual and functional condition. | None |
