# COMBINED FIRE AND HEALTH & SAFETY RISK ASSESSMENT.

| Address of premises: | 1-6 The Mews<br>Bath Road<br>Swindon<br>SN1 4BA |
| Date of fire risk assessment: | 5 <sup>th</sup> November 2025 |

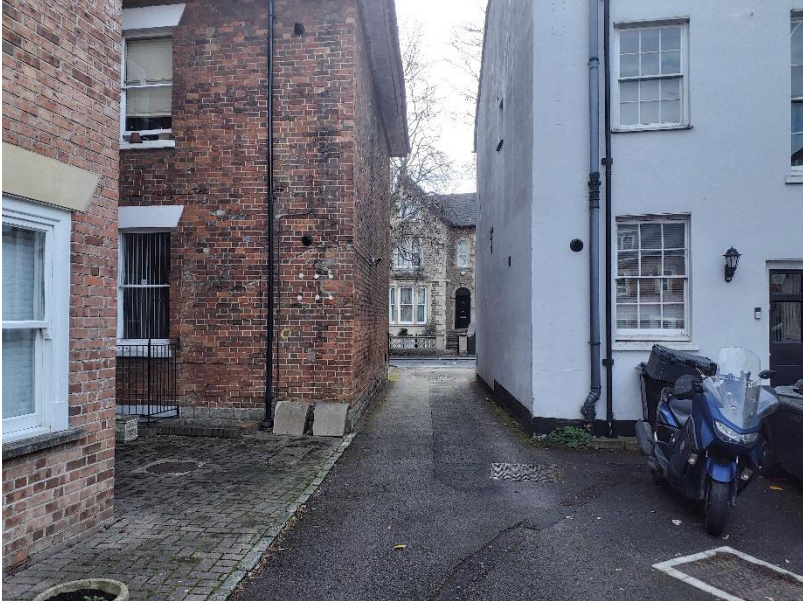
| Item | Recommendation | Priority | Timescale |
|---|---|---|---|
| 01 | <p>It was noted during this fire risk assessment that the narrow approach could cause access issues for a fire appliance. It is therefore recommended that the RP liaise with the Dorset and Wiltshire Fire Service to arrange a familiarisation visit.</p> | 1 | B |

Action  
required

DH to  
arrange

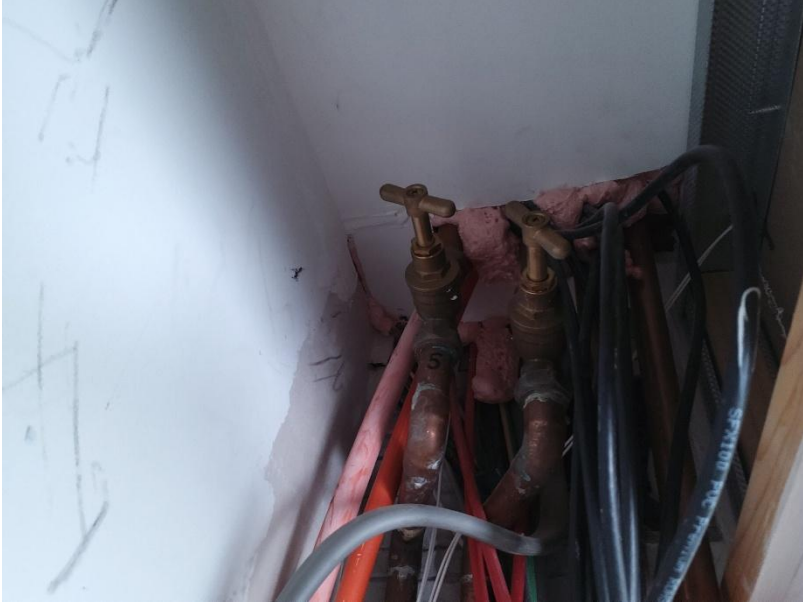
| 05 | <p>It was noted during this fire risk assessment that there was an overuse of pink foam. Pink foam is to be used as sealant only as the integrity for filling breaches cannot be verified due to the changes in viscosity. It is therefore recommended that this is replaced with a suitable compound capable of providing a minimum of 30 minutes fire resistance.</p> | 2 | B | <p>Action required</p> <p>Contractor to review and action as appropriate</p> |

| <p>It was noted during this fire risk assessment that there was an overuse of pink foam. Pink foam is to be used as sealant only as the integrity for filling breaches cannot be verified due to the changes in viscosity. It is therefore recommended that this is replaced with a suitable compound capable of providing a minimum of 30 minutes fire resistance.</p> | | |
